BENTON LAKE NATIONAL WILDLIFE REFUGE

ANNUAL NARRATIVE REPORT

Calendar Year 1985

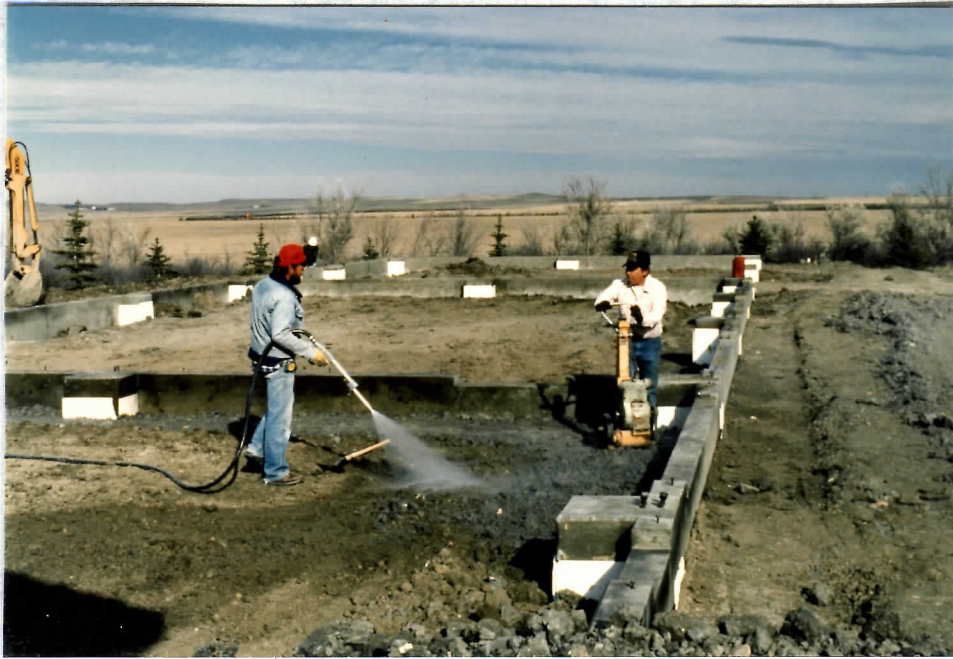
Subcontractor moisturizing and compacting 8 inches of sub-grade clay materials to bring it up to optimum moisture content and 95% proctor density compaction to form the base for a 40' x 40' concrete floor. The theory was to expand the clay and seal the moisture in so it won't move!?

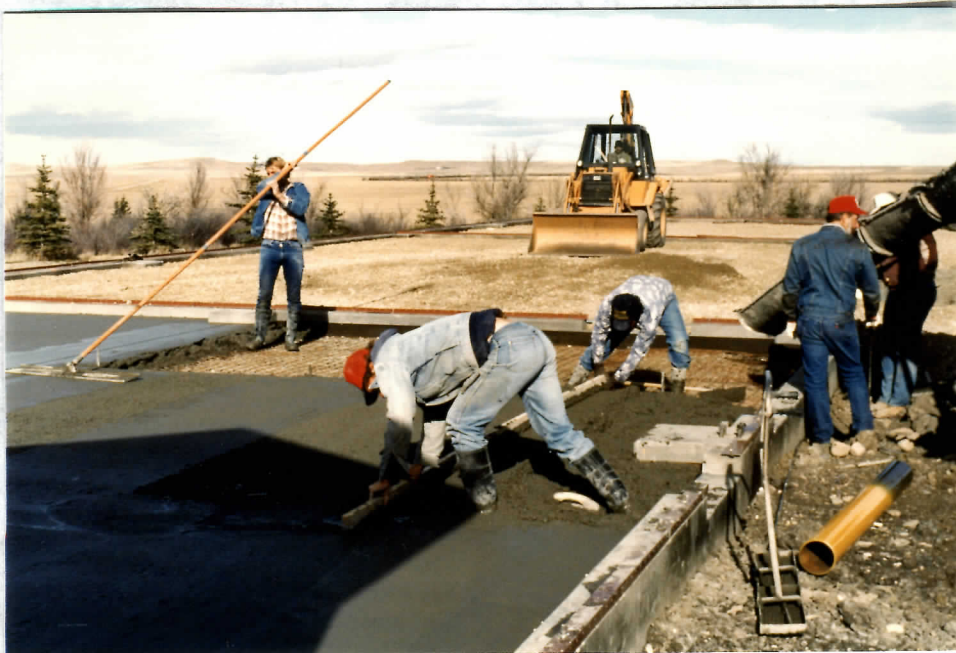
Subcontractor placing and finishing 40' x 40' concrete slab as Scott Foster places gravel flooring in the remaining bays.
11/04/85 85-18-28 RLP

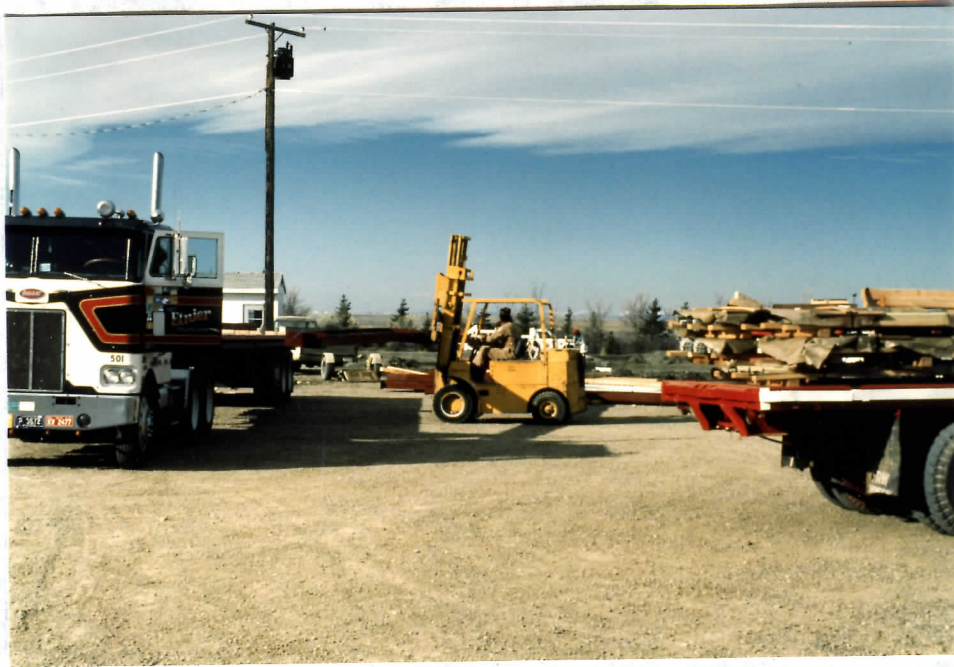
Refuge Maintenceman Scott Foster operating the forklift helping the contractor off-load the steel for the new storage building. Roof and wall sheeting are on truck to the right.
10/30/85 15-14-6 RLP

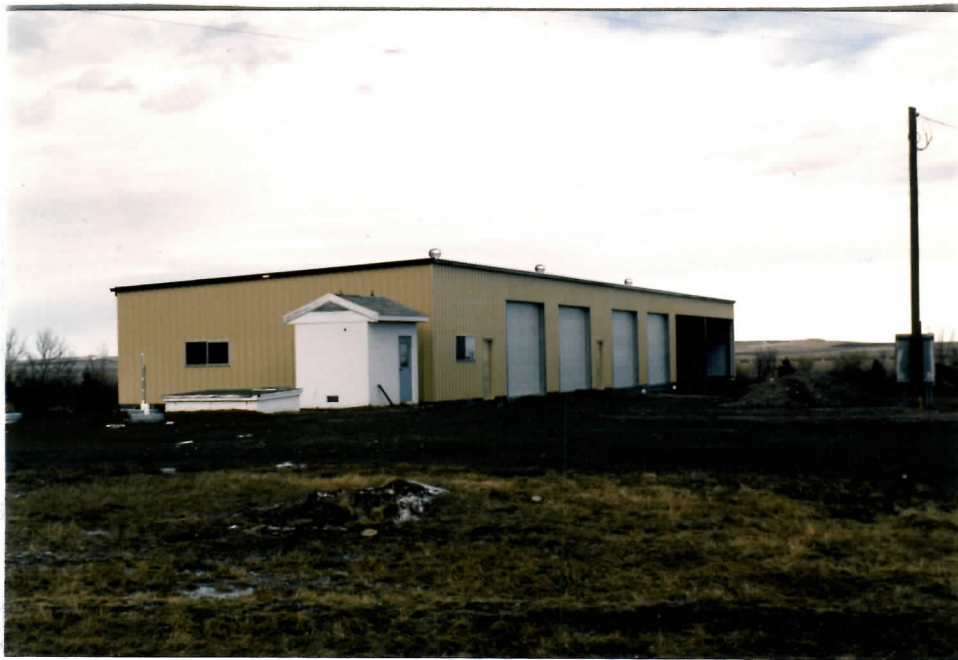
By the end of the year, the contractor had completed this \$74,205 contract except for a few small items. Final concrete work will await warmer temperatures this spring when the 3' x 90' front apron will be placed. Metal pipe bumper posts will be set in to protect the door frames inside and out at each of the overhead doors.

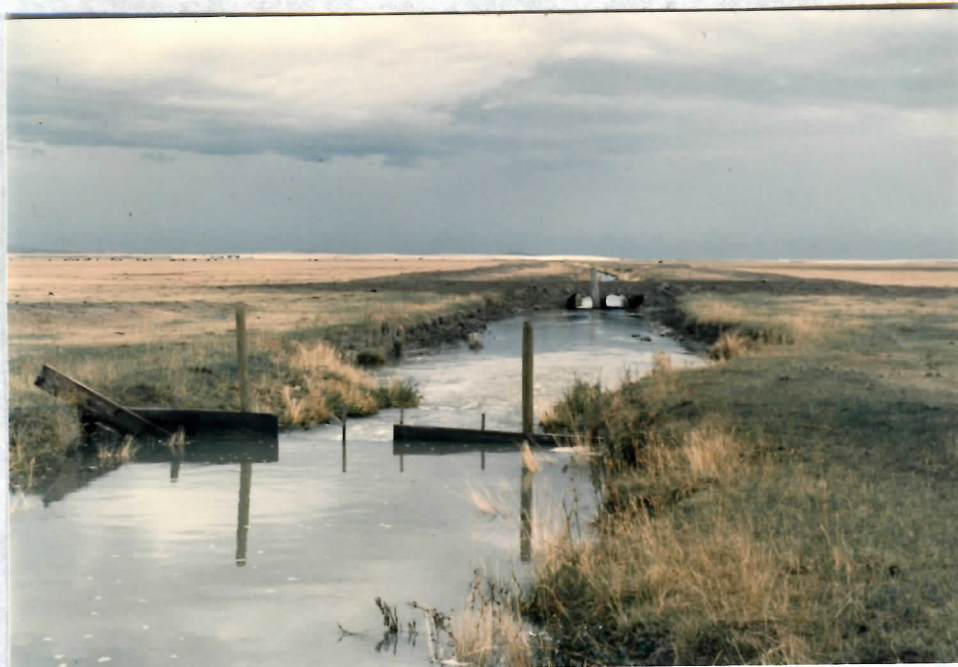
Original (1958) design of structure #29 along Lake Creek didn't provide a necessary turn out diversion for delivery of water to a private stock pond (mandated). Jury-rigged plank and posts in foreground,
09/84 84-11-16 RLP

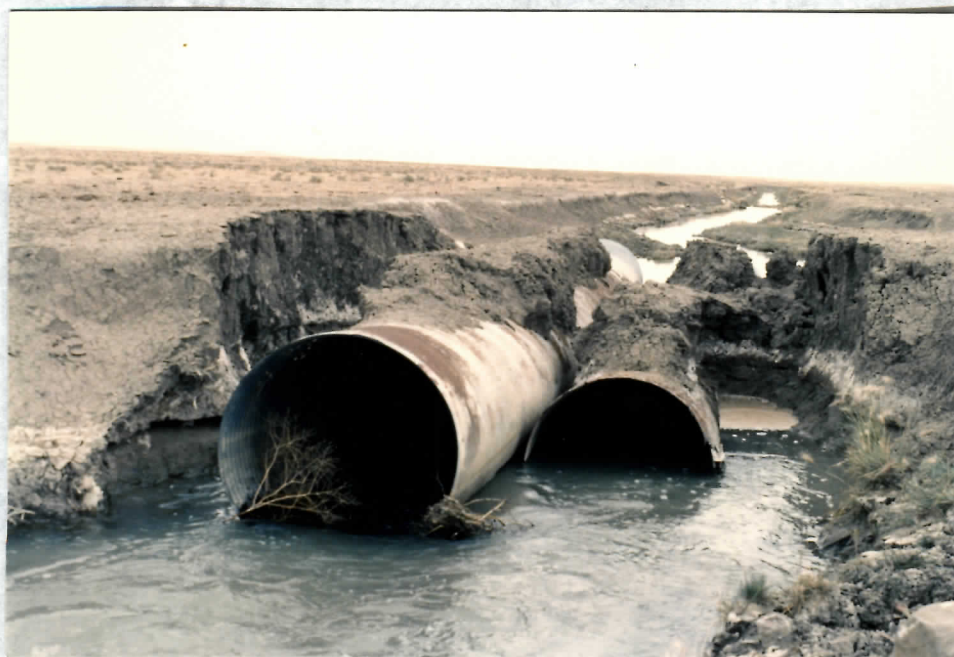
This farm crossing and water diversion point (structure #35) is somewhat the worse for wear - - alkaline corrosion, electrolysis from an adjacent crude oil pipeline and flood waters over the past 23 years have taken their toll.
09/84 84-11-9 RLP

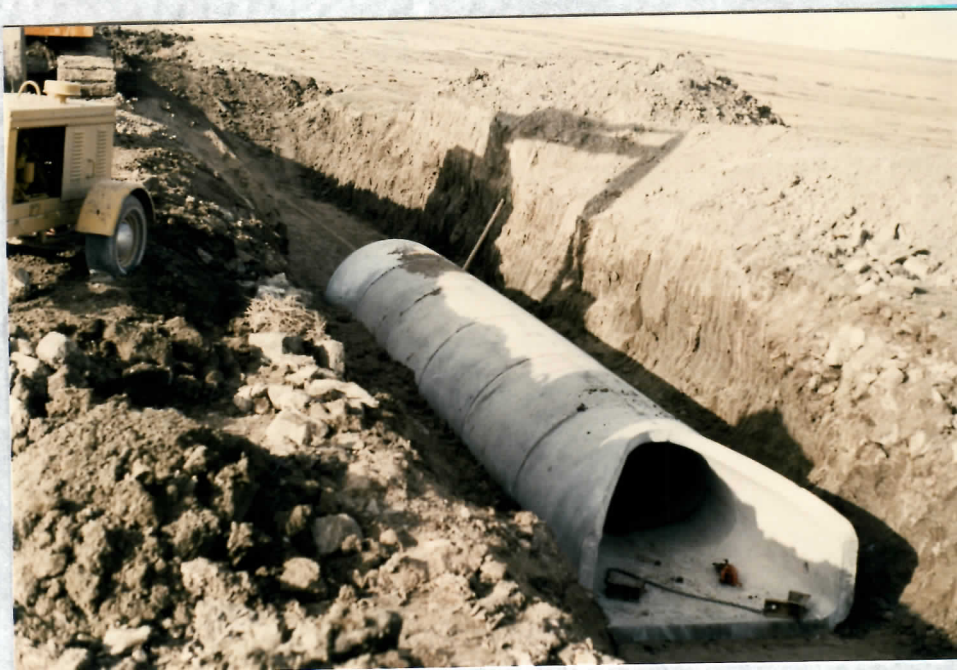
Structure #31, being replaced with concrete arch pipe, was the longest crossing due to its section line location with vehicle access needed on both sides of the fence,
11/09/84 84-15-29 RLP

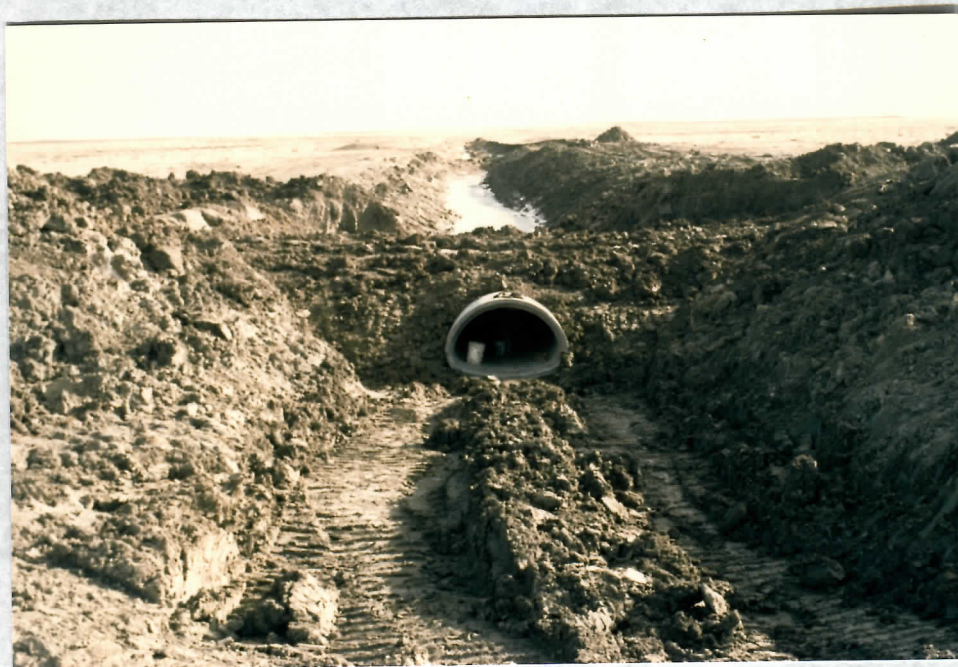
Wet and cold weather, contractor inexperienced with the ram neck joint seal gasket, poor joint alignment and compaction led to the contractor's having to excavate and reset this structure (#35).
11/09/84 84-15-36 RLP

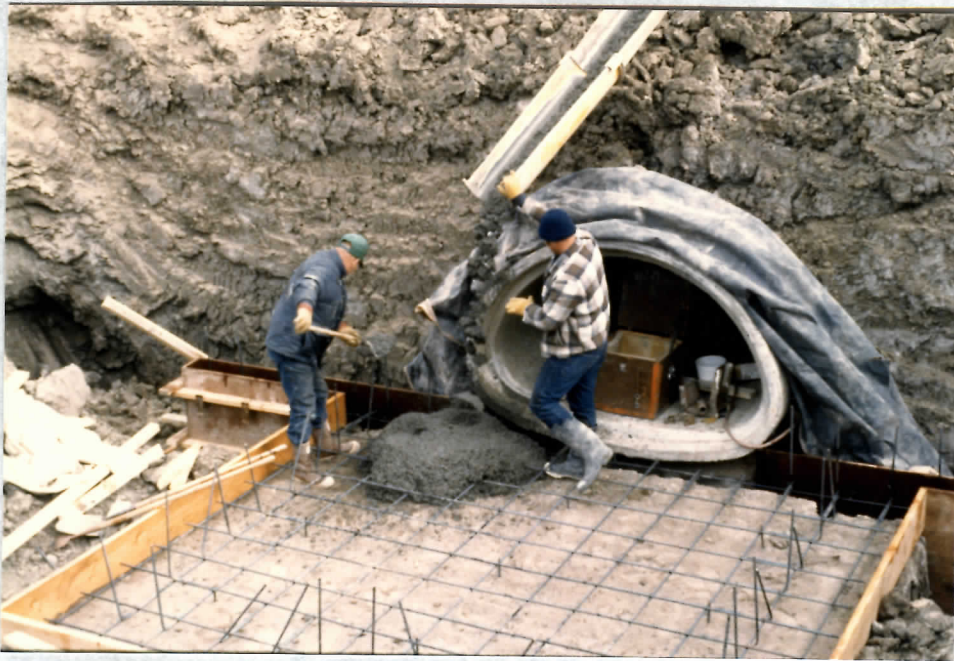
The shoddy work of this contractor soon became evident, incomplete excavation and compaction, no visqueen, no vibration of footing wall and inconsistent effort of protecting fresh concrete from cold temperatures - inspection became frustration.
11/09/84 84-16-17 RLP

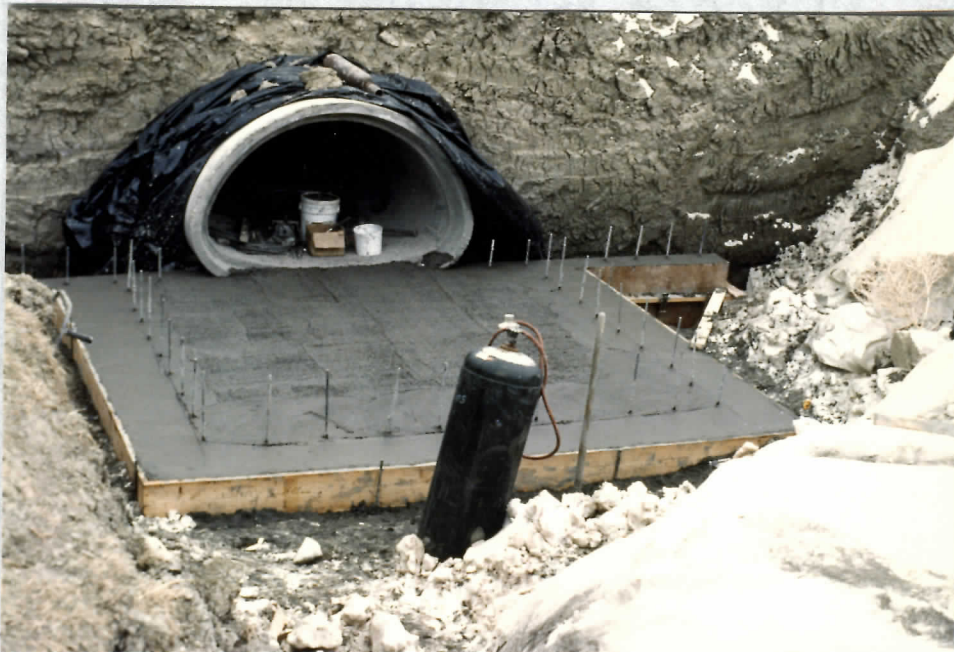
Winter weather in Montana, ungravelled access roads, and the construction site some 15 miles from headquarters added to the daily inspection task. The contractor finally shut down on 12/21/84. Note snowdrift on right.
12/07/84 85-1-12 TT

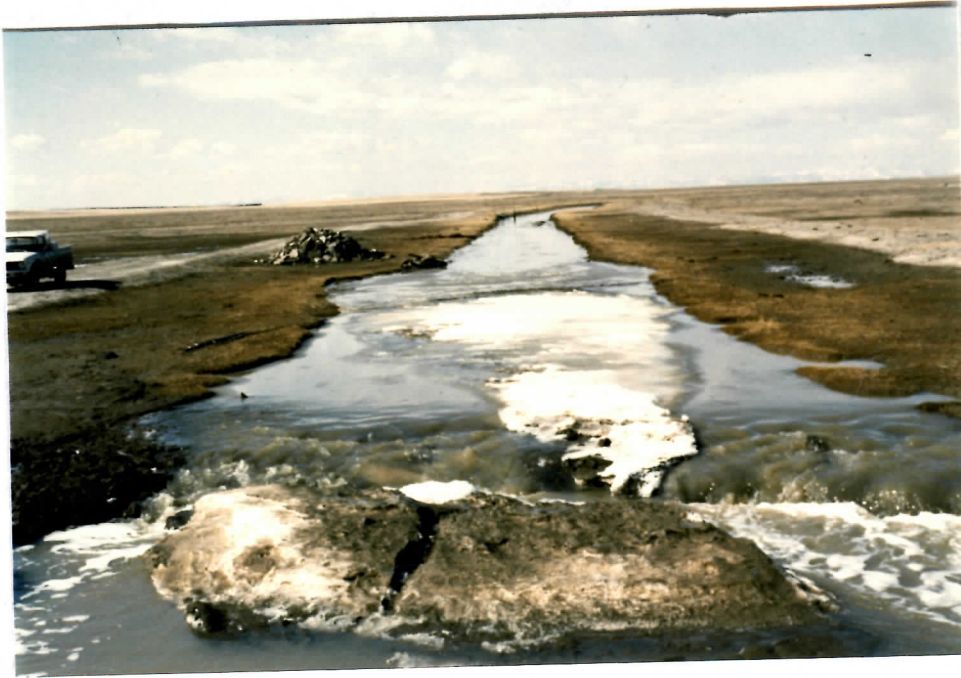
The contract called for an approved plan to protect the construction site from water. Spring runoff was extremely light, but runoff flowed freely through all three partially completed drop inlet structures.

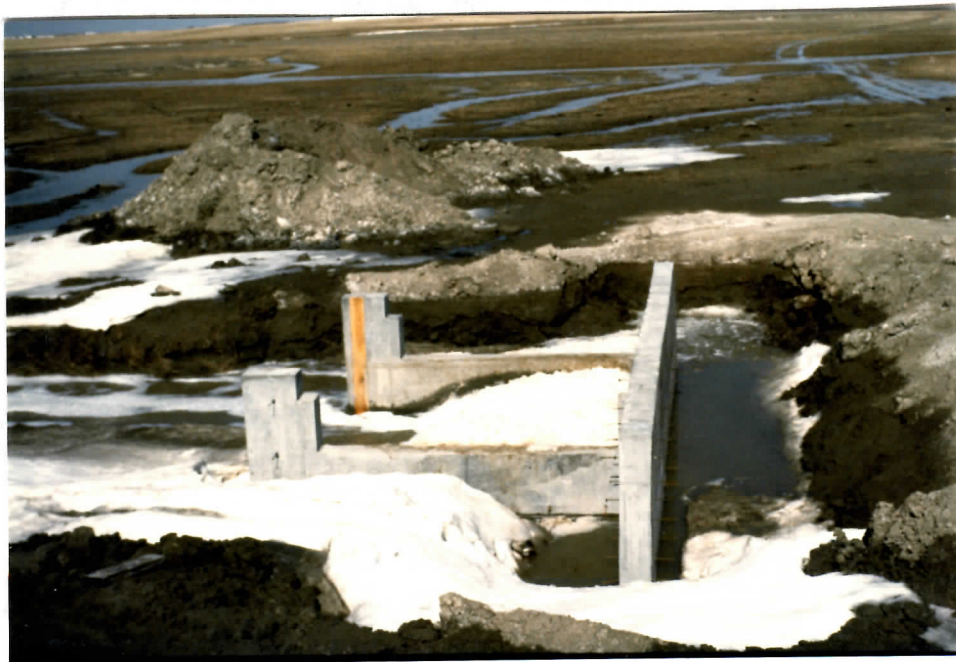
Spring flows in Lake Creek partially overflowed the adjacent pasture as well as through and all around the new structures (structure #31).

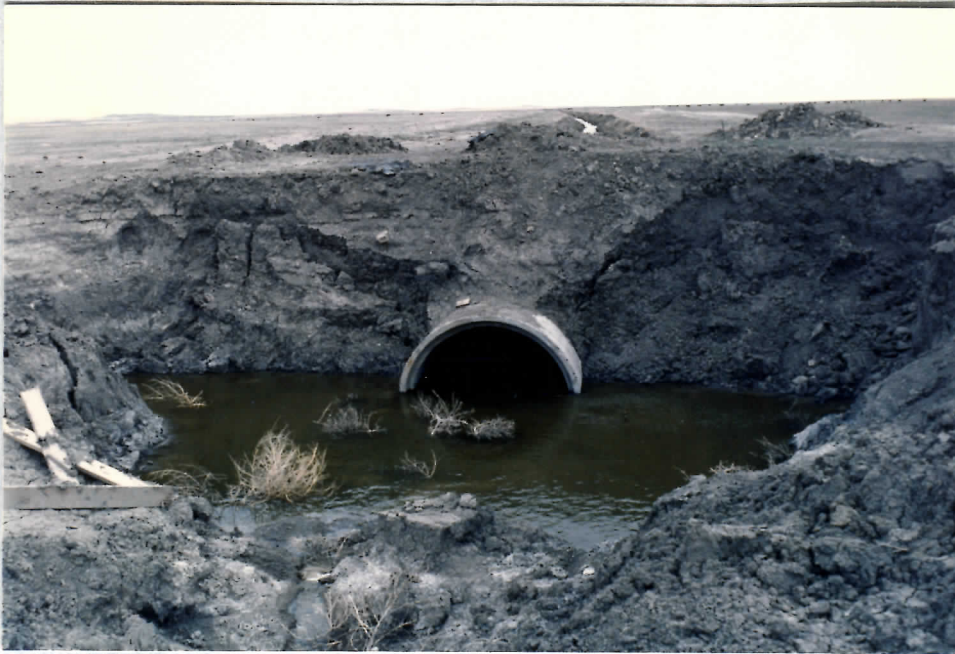
When spring runoff ceased, the "protective" canal dirt plugs retained water in the construction work site. After some delay, the contractor finally responded to our request to dewater the sites and get on with the construction.

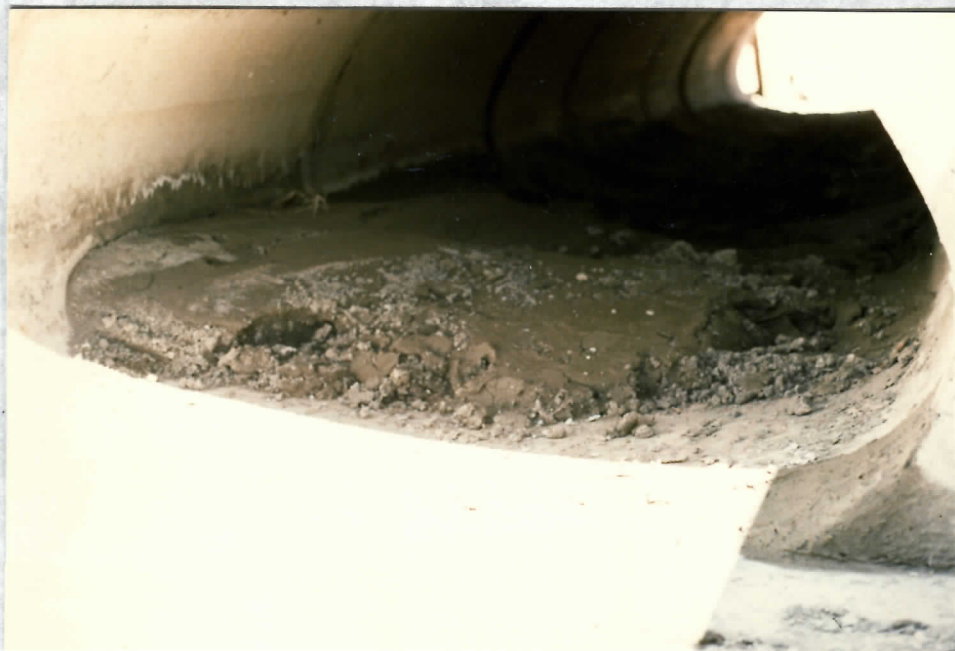
During spring runoff, about one foot of silt was deposited in the arch pipes of structures 29 and 31. Most of this had to be removed by the contractor to allow inspection of repair of pipe joints. We became concerned about the hydraulic design on these structures in relation to future silt deposits.

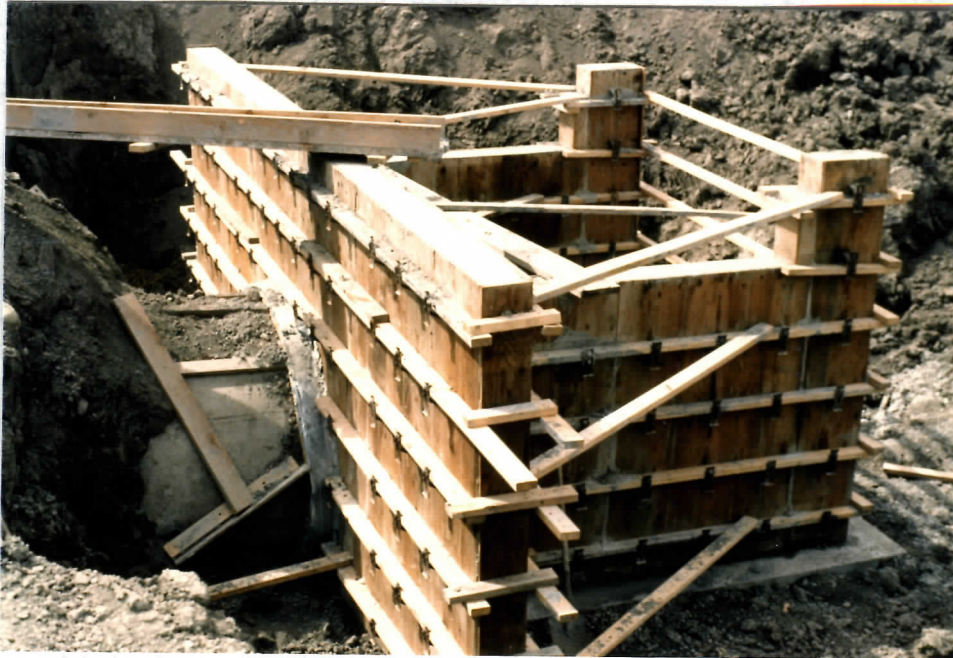
The contractor was informed in early April of the need to begin pumping water through these structures by May 24th. Drought conditions were adversely affecting habitat at the refuge. The last structure (#29) was finally poured May 8th.
05/08/85 85-6-8 RLP

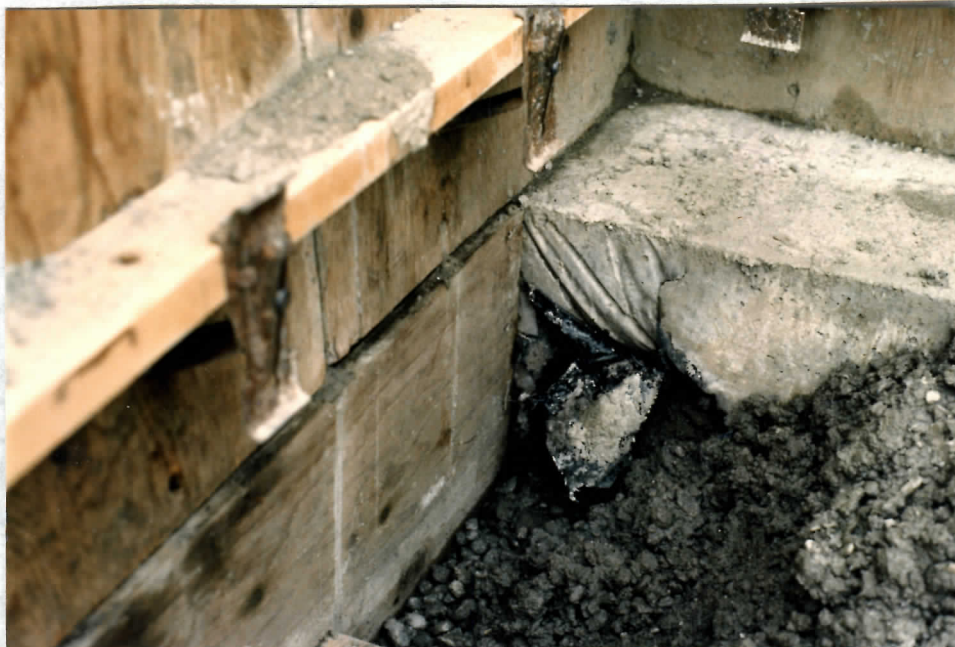
Failure to read and heed contract specifications and continued shoddy workmanship was the rule. Note the visqueen which was used to cover the dirt form wall at the junction of the structure. The concrete at this critical point was only 5½" instead of the 9" called for in the specifications and drawings.
05/08/85 85-6-10 RLP

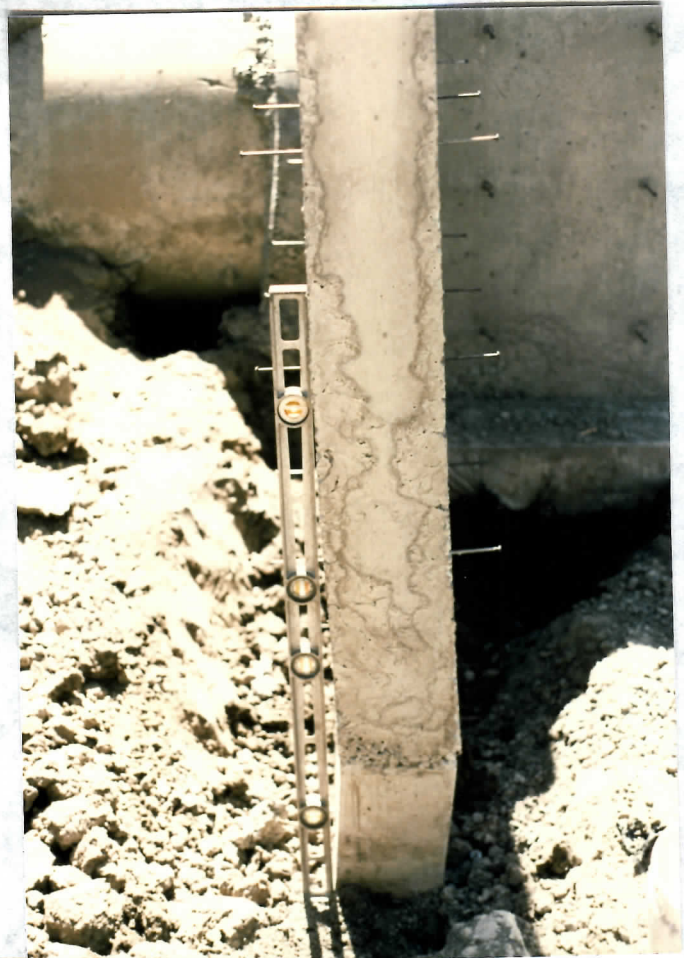
"Formed" collar at junction of arch pipe and cutoff wall.
The large void under the pipe was filled and compacted with
a soil and cement mixture or "soilcrete" as per Engineer
Ken Fox's advice.

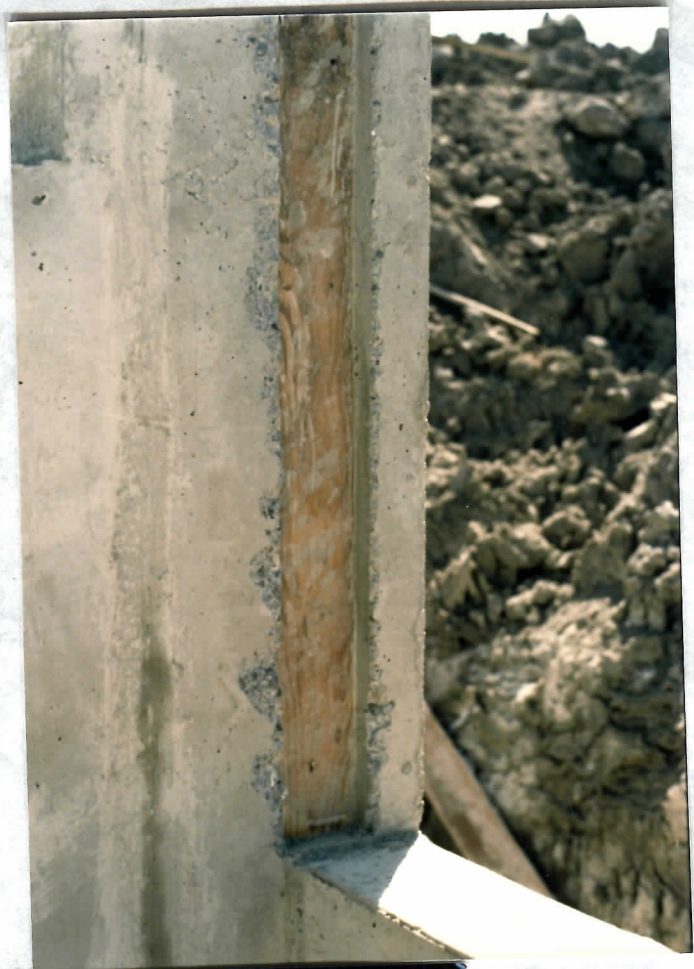
Stop log slot detail showing form method. Note hairline
crack lower inside corner running toward outside (left) of
structure #31.
05/22/85 85-7-23 RLP

Lake Creek structure #29
with the first of two slot
forming boards removed. A
problem of both design and
construction method. No
reinforcement in slot areas of
concrete and moisture uptake
in wooden form blocks caused
the concrete to crack. The
slot should have been formed
with (aluminum) channel iron
with anchor ties into the
concrete and rebar. See July
16 photo of same.
05/13/85 85-6-23 RLP

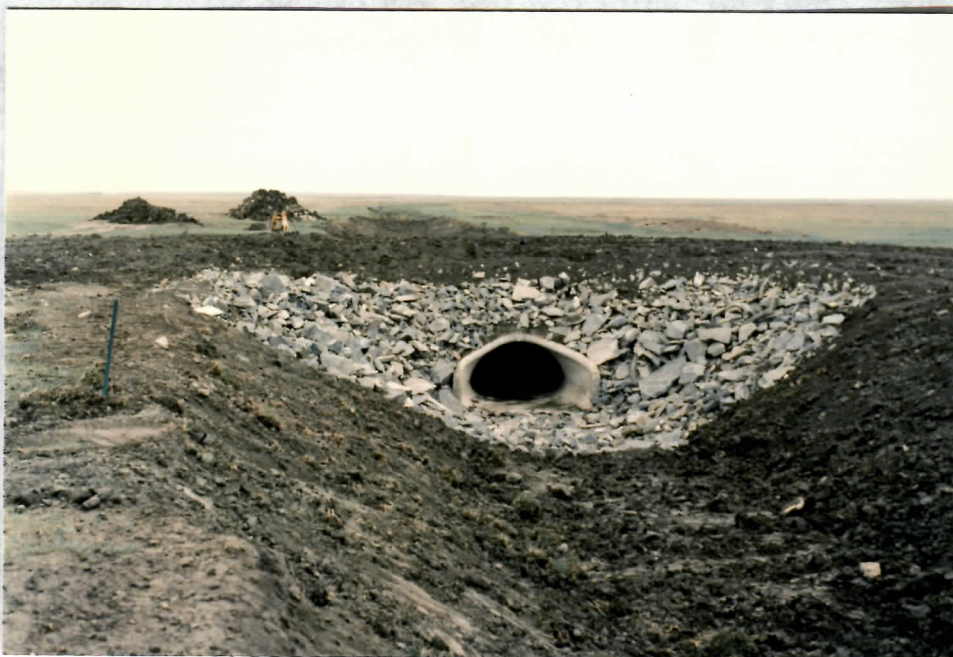
Structure #29 outlet: angular granite rip rap was placed at the outlet. A bedding of sand (10'x12'x6") was placed under the rip rap on the outlet canal bottom, instead of under the entire rip rapped area. Drawing detail error in contract.

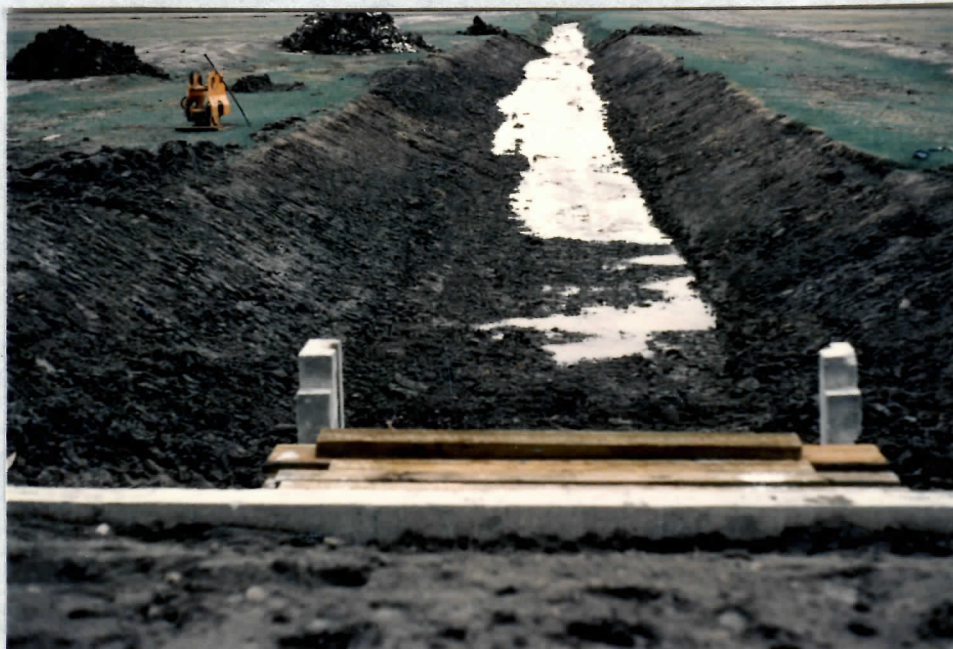
Due to a critical water shortage at the refuge, the Muddy Creek pumps were turned on before the contractor was finished, as allowed under the contract terms - - thank goodness.

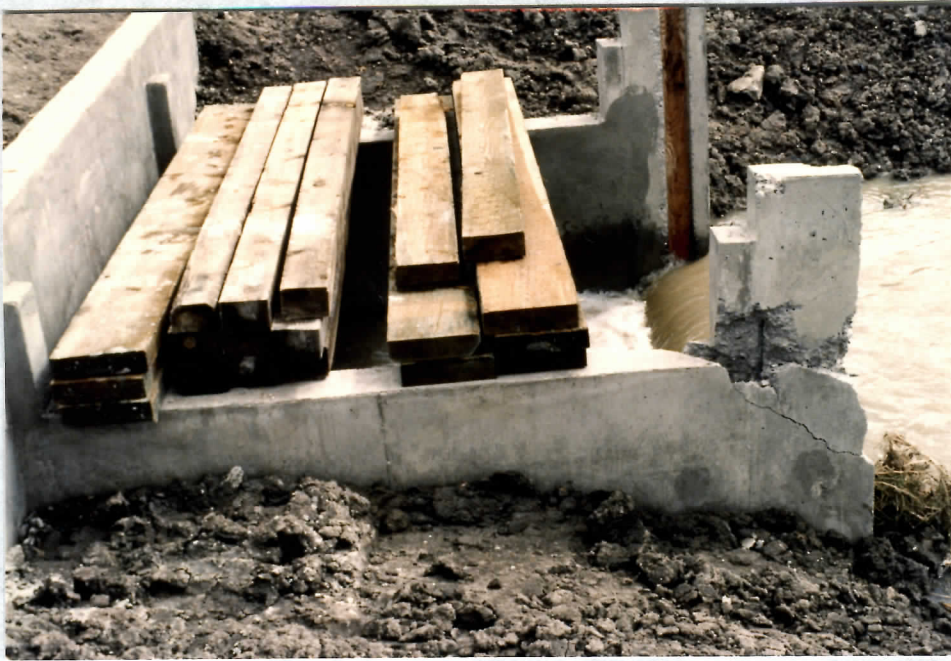
The contractor's equipment busted the north pier of structure #29 during backfill and compaction operations. Note the amount of water back pressure in the structure, silt deposited 18 inches deep in this structure with only one pump operating.

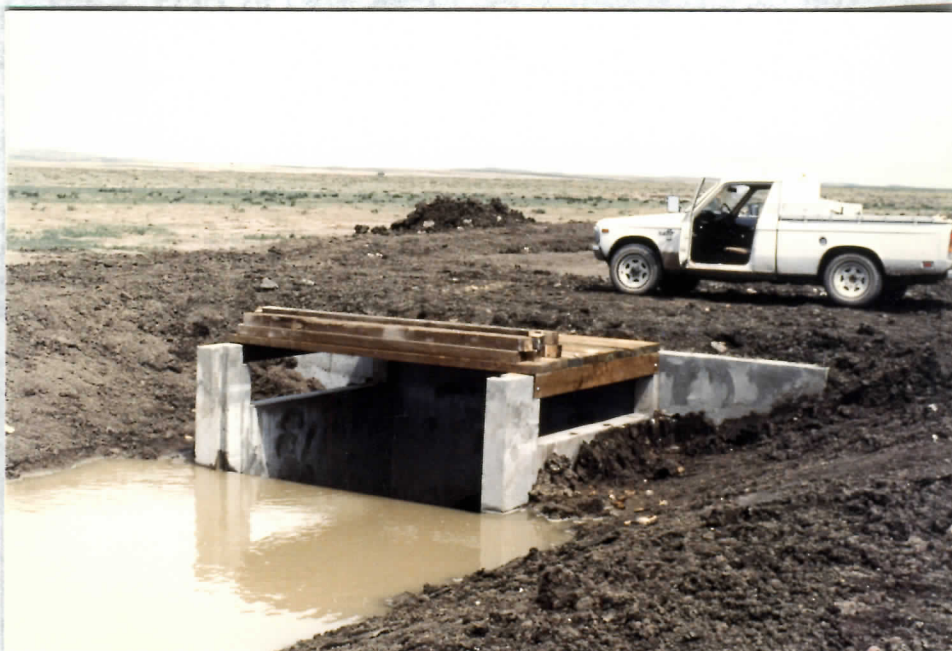
Newly completed structure #35 with one pump operating (16 cfs). Note the lack of water back pressure, no silt deposit problem occurred with this structure.

The design of the structures was to fill two of John Burgmaier's stock ponds. Structure No. 29, completely closed with stop logs and with three pumps running, resulted in 3 inches of water running into the pond, while the remainder went over the overflow. Structure No. 35 did not raise the water high enough to divert any water into the stock ponds.

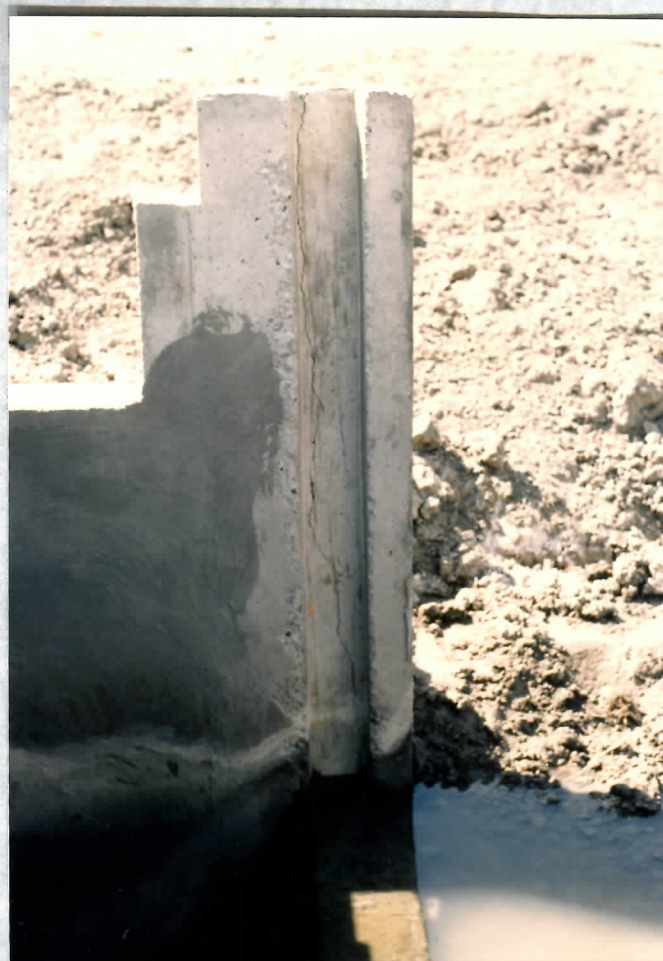
As is shown here on the south pier of structure #29, serious cracks were present on all structures when the form boards were removed. The contractor was asked by Engineering to grind out a notch in the cracks and grout over with wellcrete sealant. The result looked good - - and might hold through the warranty period - - or maybe not. A 30 inch segment of the outer lip on the south pier of structure #35 came off during the winter of 85-86.

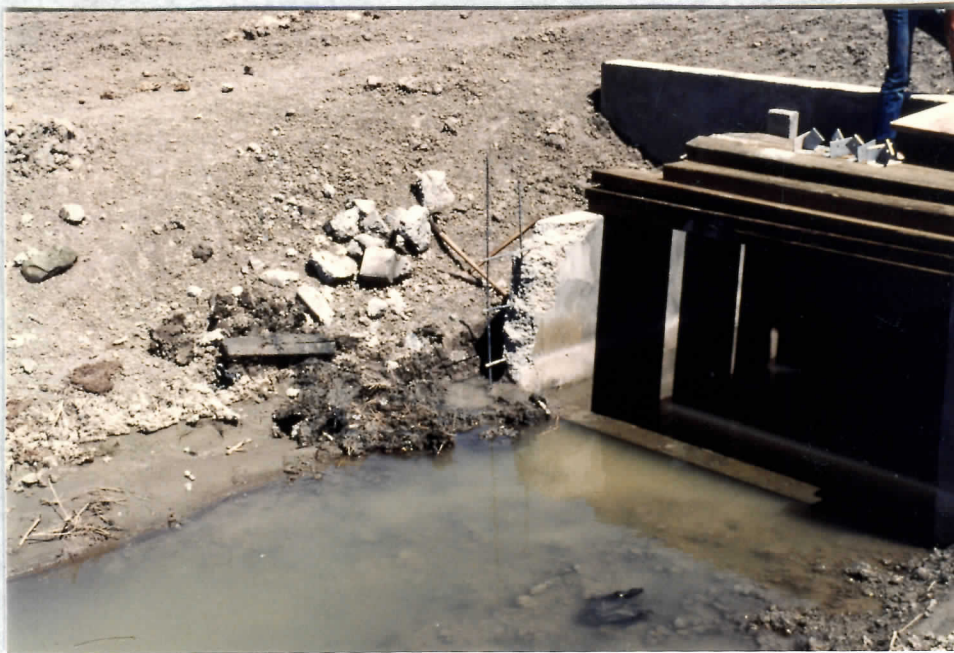
After water in Units I and II was replenished the pumping was shut down long enough for the contractor to remove, reform and pour the north pier on structure #29.

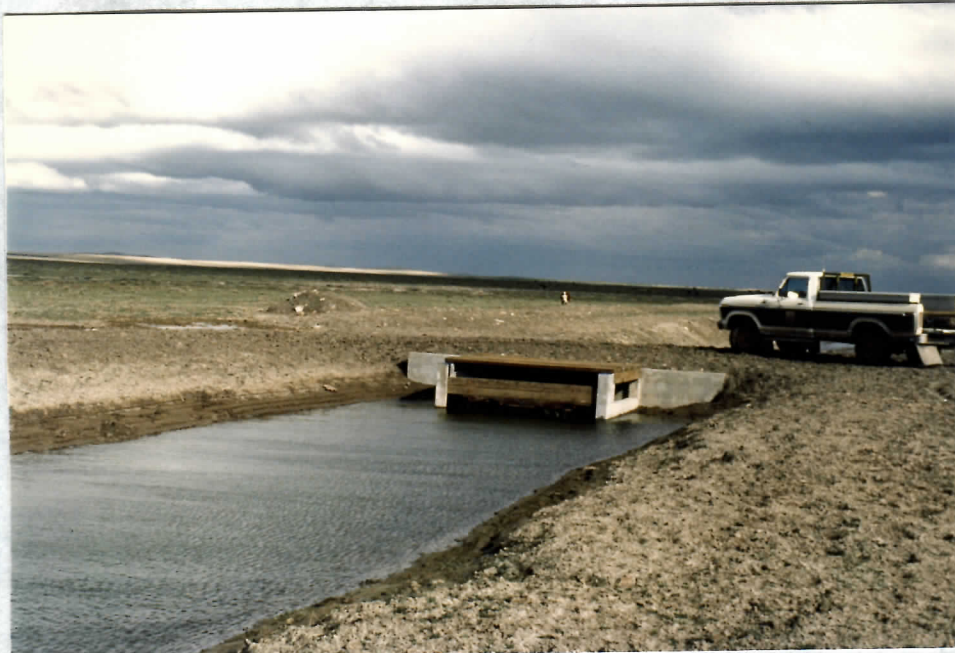
All of these structures under the Lake Creek contract were supposedly designed with both a drop and a diversion function. This photo shows residual water held at structure #35 following an unsuccessful attempt to divert water into an adjacent stock pond. At full pumping capacity (3×16 cfs) all of the water was being passed through the side spill slots on this structure. The stock pond canal was 0.9 foot higher than the structure spill slots.

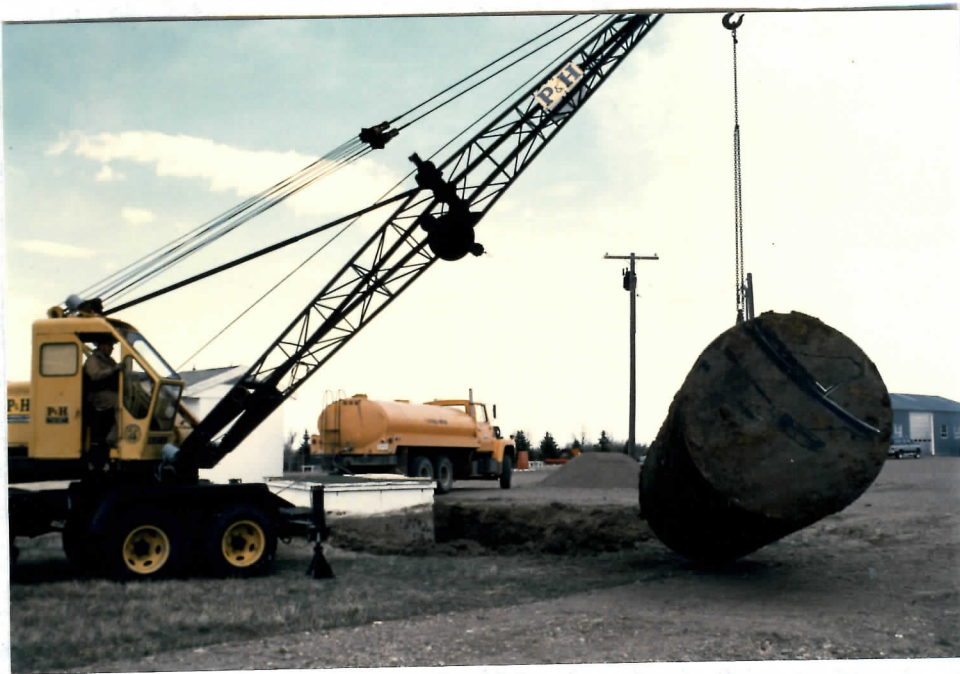
Marko removing the 4000 gallon cistern tank after 24 years of service at headquarters. All potable water must be hauled in. The 3000 gallon water truck served as a temporary water supply during the rehabilitation.

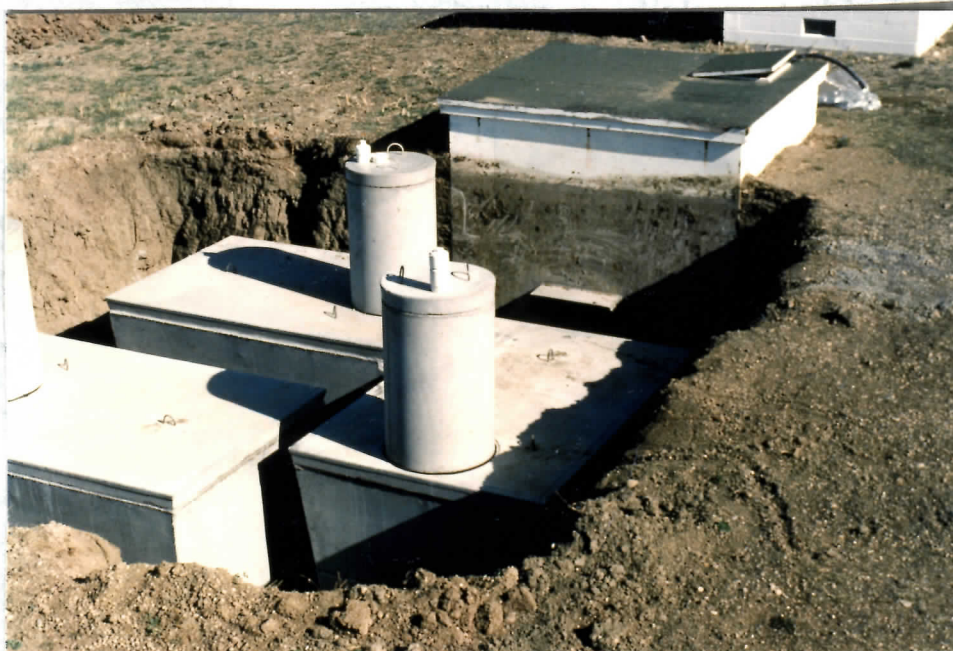
The three 1500 gallon concrete units nestled in beside the buried pumphouse where a new pressure system was installed. Water service is much improved. Marko also developed a visual sight gauge to measure the water supply.

In April three new 1500 gallon concrete cisterns were installed to replace the 4000 gallon metal tank. Time and elements finally caused the old tank to rust through and the fill spout to break out. The new tanks were buried in the ground about ten feet deep, connected together using plastic pipe, and hooked up to a new bladder style pressure tank and pump. This new system also took care of the low water pressure at quarters 82 which is at the end of the water line.

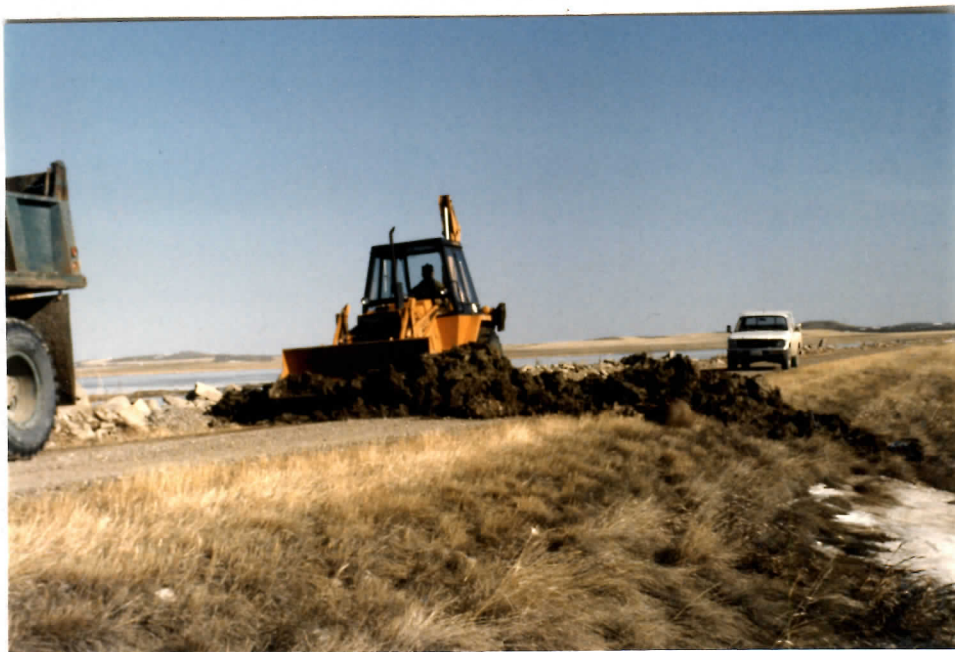
Muskrat damage to the Unit I dike being repaired by the maintenance crew.

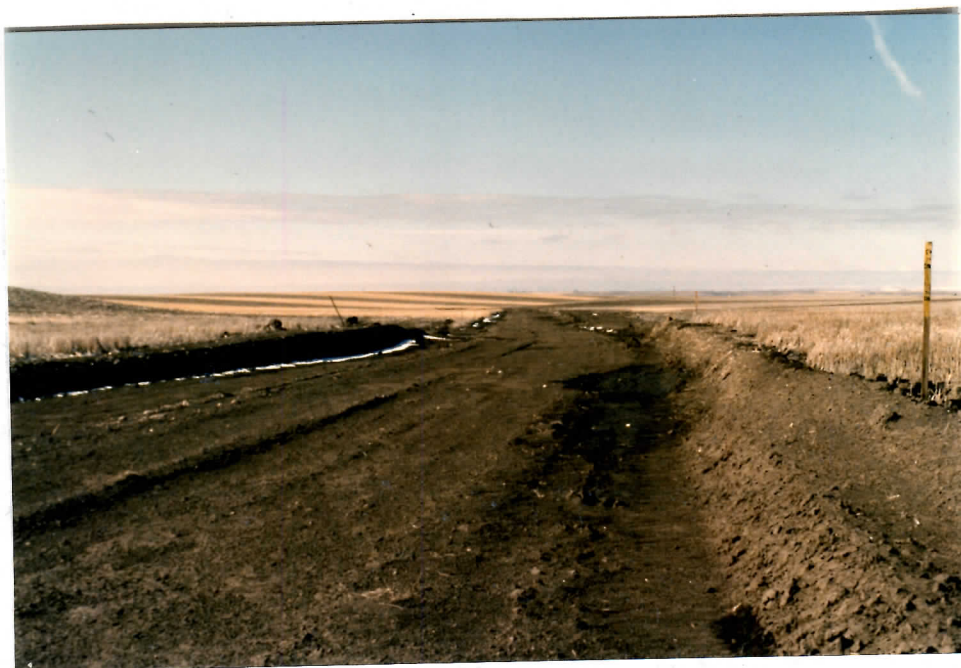
This scraper ditch, designed to drain one of the wetlands on Glacier County easement 24X-1 was restored by the landowner.

The scraper ditch violation detected on November 16, 1983, on Glacier County easement 24X-1 was restored in June. The landowner

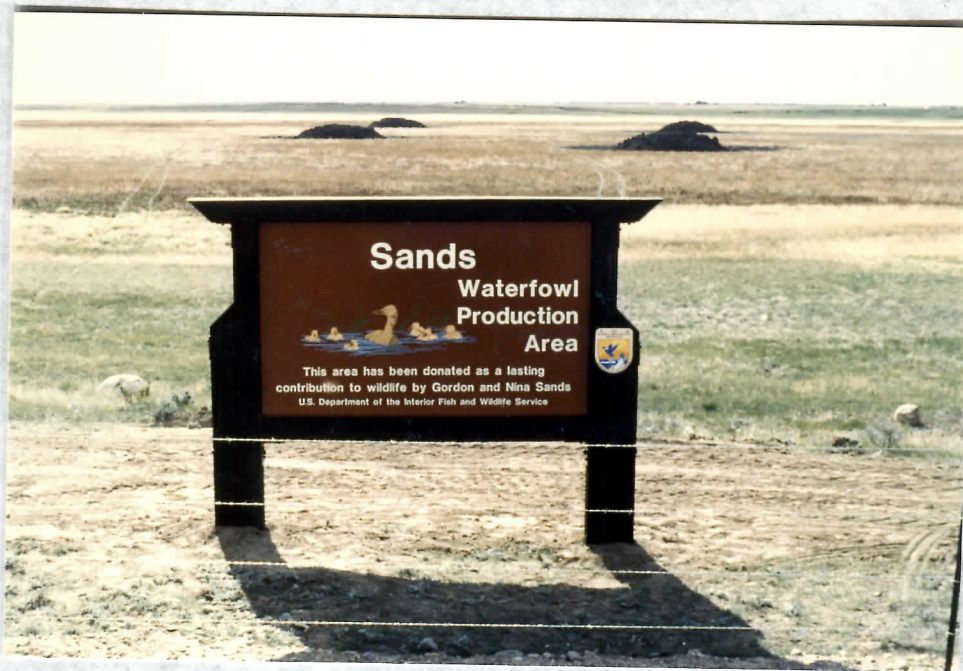
The erection of the Sands WPA sign and the fencing of the parking lot with walk-through access completes the initial development work for this WPA. Ten islands were constructed in the basin during the fall of 1984.

Construction this year was limited to the development of the Sands WPA. A special recognition Sands WPA sign was purchased and a base constructed near the public parking area. The parking lot was fenced with walk-through access provided.
